# **Big Star Lake 2018 Aquatic Vegetation, Water Quality, and 2019 Management Recommendations Report**

**December, 2018**

*The following Big Star Lake report is a summary of key lake findings collected in 2018.*

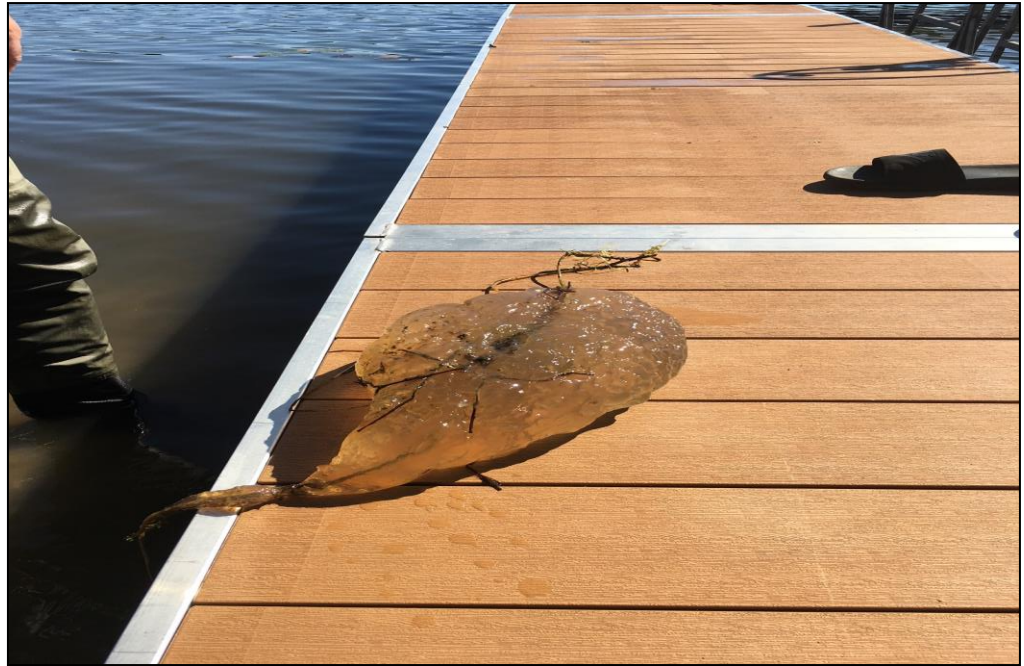
previous years as well and was moderately low even at the lake bottom. The total nitrogen in considered moderate as well. There were some large bryozoans (shown below in Figure 1) that were found in the water. These are like freshwater corals that form mucilage-like outer layers around them to keep them moist and to be able to trap algae to feed on. They are an indicator of productive yet healthy lakes. Though unsightly, they are harmless.

**Figure 1. A freshwater bryozoan found in Big Star Lake.**

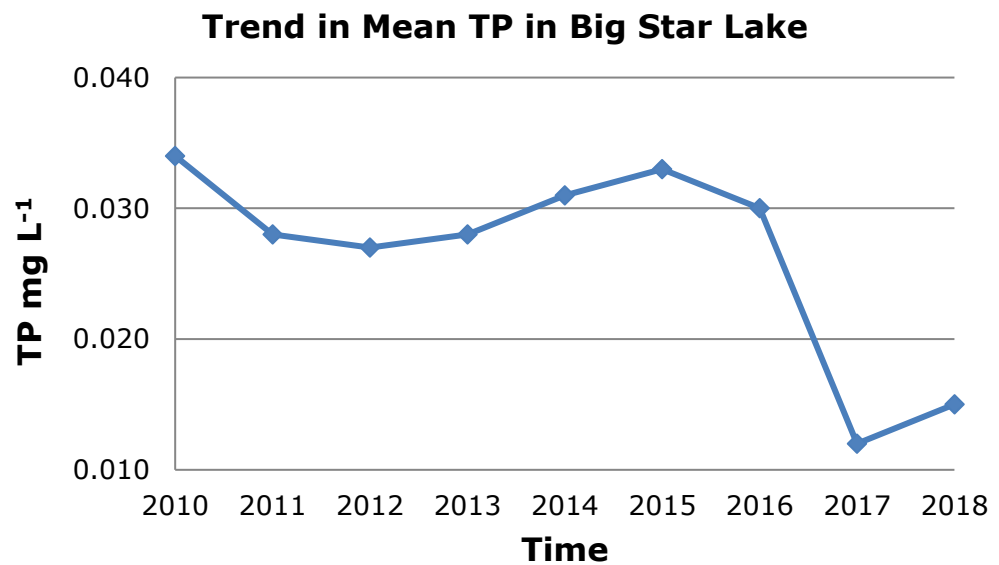
Total phosphorus (TP) is a measure of the amount of phosphorus (P) present in the water column. Phosphorus is the primary nutrient necessary for abundant algae and aquatic plant growth. TP concentrations are usually higher at increased depths due to higher release rates of P from lake sediments under low oxygen (anoxic) conditions. Phosphorus may also be released from sediments as pH increases. Fortunately, even though the TP levels in Big Star Lake are moderate, the dissolved oxygen levels are good enough at the bottom to not cause release of phosphorus from the bottom. The mean TP concentration in summer of 2018 was 0.015 mg L<sup>-1</sup> (below graph). This low concentration makes Big Star Lake a P-limited ecosystem.

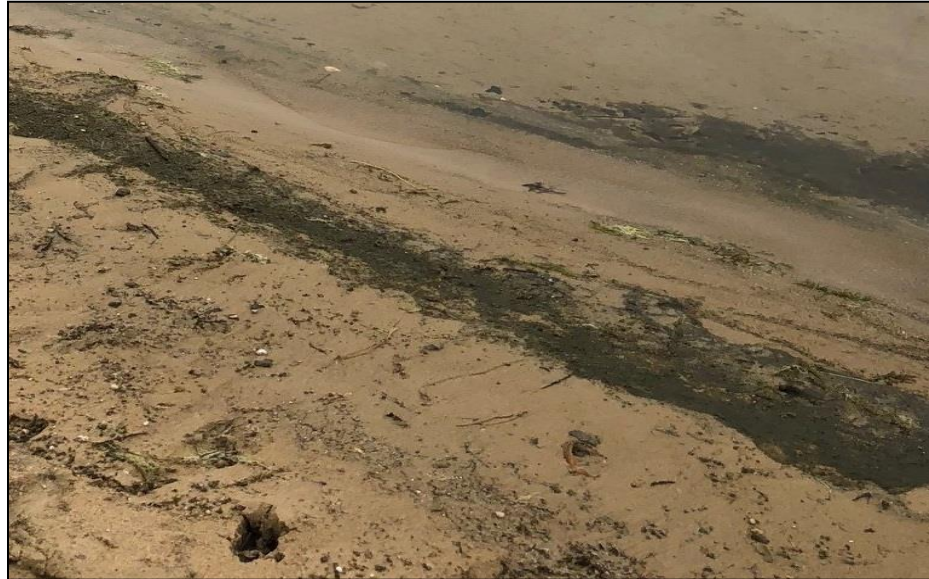
In August of 2018, Restorative Lake Sciences (RLS) was contacted by the Big Star Lake Association (BSLA) to collect sediment samples that were from shorelines and appeared as “sludge” (Figure 2 below). A map showing the locations of the 7 sediment samples is shown in Figure 3 below.

Figure 2. Shoreline “sludge”.

The canal sediment samples were all primarily fine silt and very dark in color with little sand. The open water samples (Southwest and Southeast Basins) were high in sands and low in fines. The samples collected onshore both resembled the Southwest and Southeast Basin samples. This means that the onshore “sludge” is likely originating from the lake and not the canal. This could indicate that strong wakes from wake boats may be transporting these solids from one part of the lake to another. Additional contributing factors could include intense storm events such as high winds and heavy downpours. RLS will provide educational recommendations in the annual lake progress report.

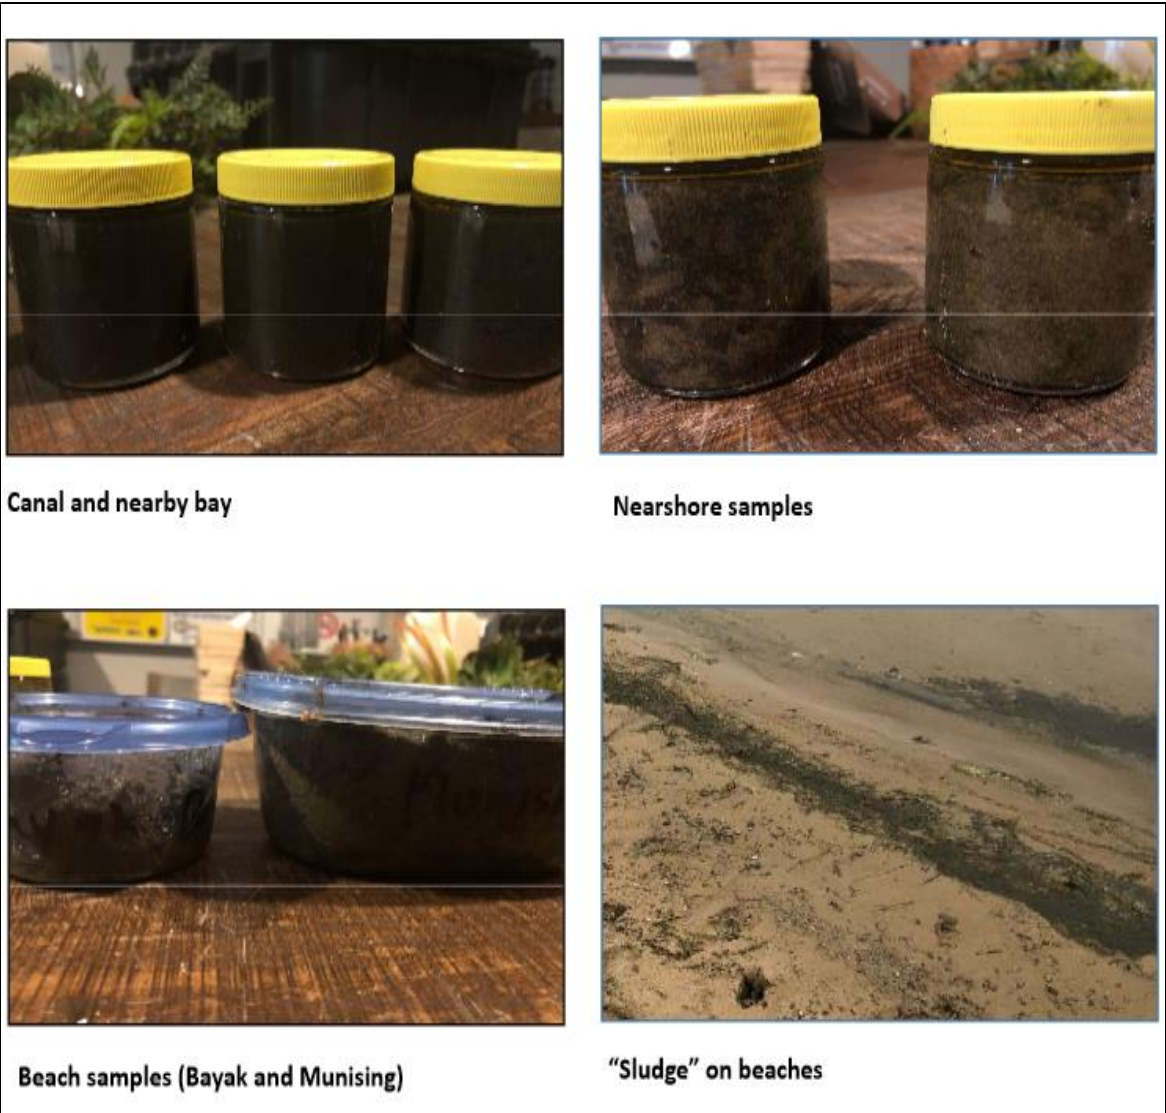
Canal and nearby bay

Nearshore samples

Beach samples (Bayak and Munising)

"Sludge" on beaches

**Figure 4. Photos of sediment samples collected from the shoreline and lake bottom.**

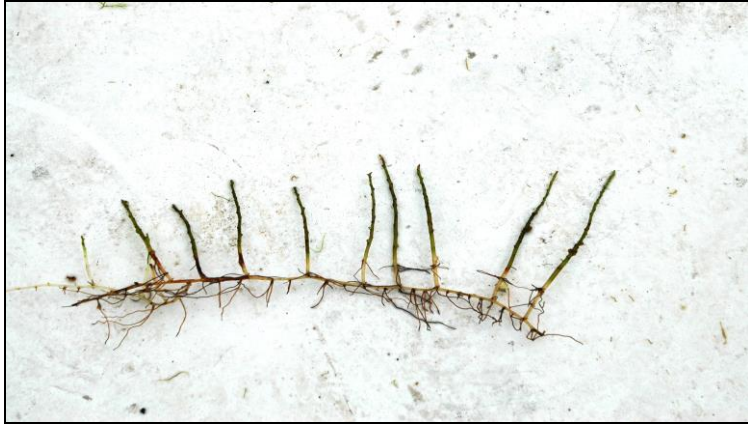
The most dominant aquatic plant species in June of 2018 included: 1) Leafless watermilfoil which appears as a small spike-like plant with fragile roots and has the appearance of sod on the lake bottom (Figure 5); 2) Common Bladderwort (Figure 6), which is bright green in color and has small clear bladders that trap zooplankton as a food source, and 3) Illinois Pondweed (Figure 7) which has a reddish-brown stem with slightly curled leaves and may form dense colonies in shallow areas and canals. All of the aforementioned aquatic plants are favorable and important components for the health of Big Star Lake.

**Figure 5. Leafless Watermilfoil**

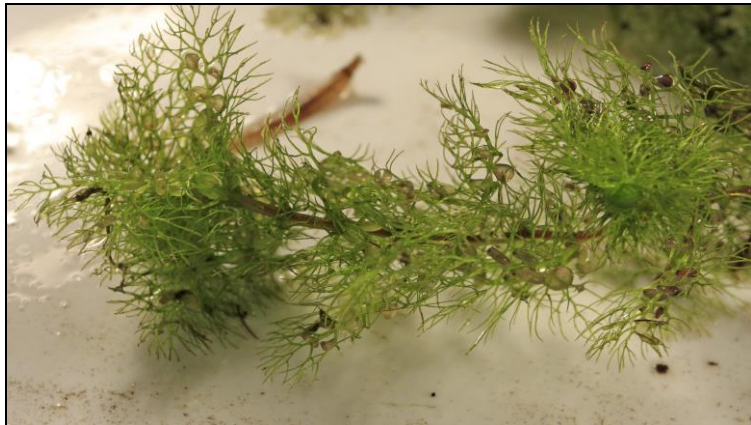
**Figure 6. Common Bladderwort**

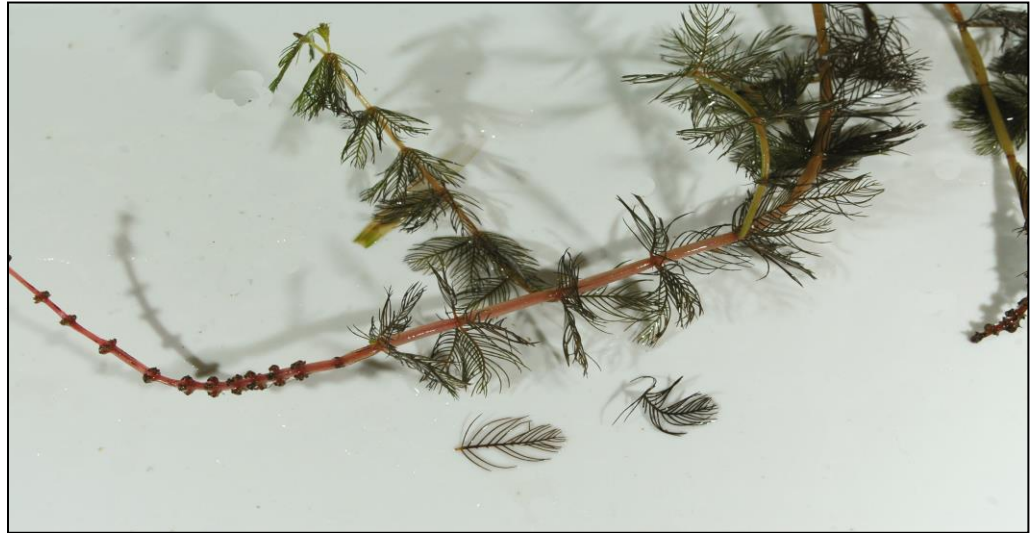
The amount of Eurasian Watermilfoil (Figure 8) present in Big Star Lake varies each year and is dependent upon climatic conditions, especially runoff-associated nutrients. In 2018, there were some intense rainfall events and this led to the transport of nutrients from the surrounding land to the lake water in many lakes and resulted in spikes of EWM and algae growth. In Big Star Lake the June 11, 2018 survey revealed that approximately 4.2 acres of milfoil was found throughout the entire lake plus less than two acres on the day of treatment. On June 25, the milfoil was treated with high dose granular triclopyr (Renovate OTF®) at a dose of 200 lbs/acre. The treatment was successful overall but late in the season another 9.0 acres of milfoil grew and also required a treatment with granular systemic herbicide which was conducted in early August.

**Figure 8. Eurasian Watermilfoil**

Aquatic vegetation surveys will be conducted in late May or early June with treatments to follow within a week or two. These surveys will prescribe treatments for EWM, CLP, and only nuisance native aquatic vegetation. During this survey, bottom scans of the lake will take place to determine changes in bottom hardness, hydrographic bottom contours and bio-mass of the existing vegetation. An additional survey after the treatment will determine the efficacy of the treatment and any follow-up treatments that may be needed. EWM will be treated with Renovate OTF® at 200 pounds/acre in near shore areas and Sculpin G® at 200 pounds/acre for areas more off-shore. Areas of less than an acre in size will be treated at 240 pounds/acre to better maintain herbicide contact in these areas. CLP will be treated with Aquathol K®. Diquat and/or Clipper® will be used on the nuisance native aquatic weeds if necessary. Areas in the wetlands near the boat launch and the marina will continue to be emphasized for possible treatment.
