# **Big Star Lake 2023 Aquatic Vegetation, Water Quality, and 2024 Management Recommendations Report**

**November, 2023**

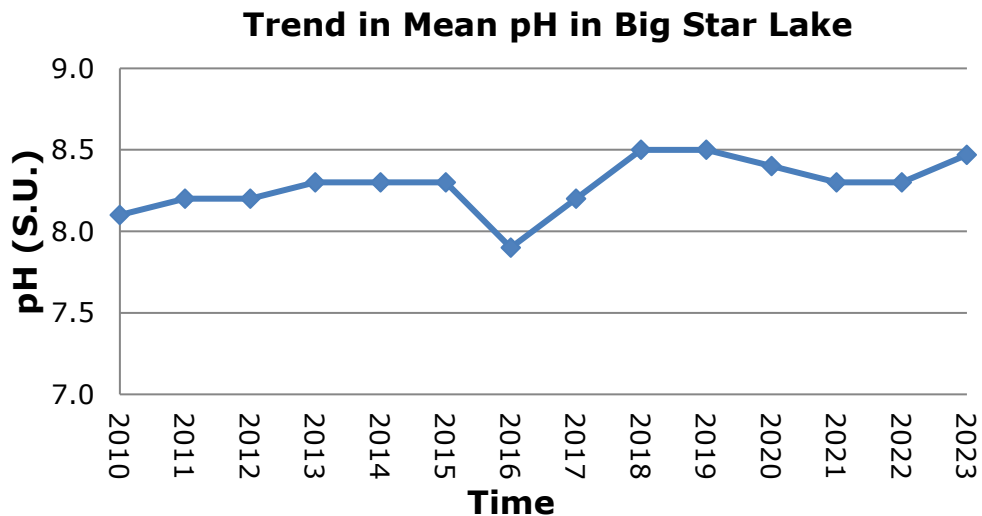
Most Michigan lakes have pH values that range from 6.5 to 9.5. Acidic lakes (pH < 7) are rare in Michigan and are most sensitive to inputs of acidic substances due to a low acid neutralizing capacity (ANC). Big Star Lake is considered “slightly basic” on the pH scale. **The pH of Big Star Lake averaged 8.47 S.U. (below graph) in the summer of 2023 which is ideal for an inland lake that has a healthy aquatic vegetation community with active photosynthesis.**

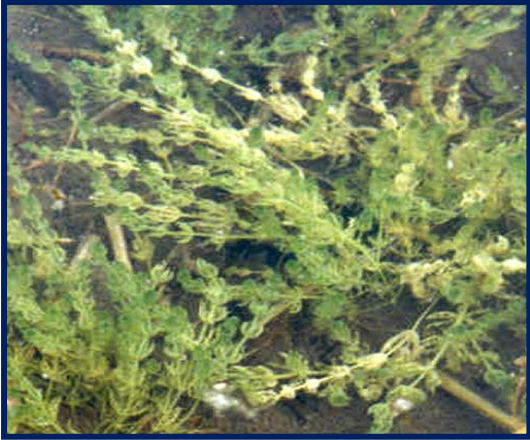
**Figure 4. Chara**

The most dominant aquatic plant species during the August 7, 2023 survey included: 1) Chara (Figure 4) which has a skunky odor and lies on the lake bottom. This macroalga is beneficial since it prevents EWM from rooting in the lake bottom and thus its growth is encouraged; 2) Southern Naiad (Figure 5); This plant has very slender green / purplish leaves that are 1/16 inch wide. It is a great bottom cover providing habitat for micro and macro invertebrates along as providing food for waterfowl with its seeds; 3) Wild Celery (Figure 6) which also has a tall grassy appearance. When it reaches maturity the seed heads will reach the surface in a spiral pattern with a small seed head on top.

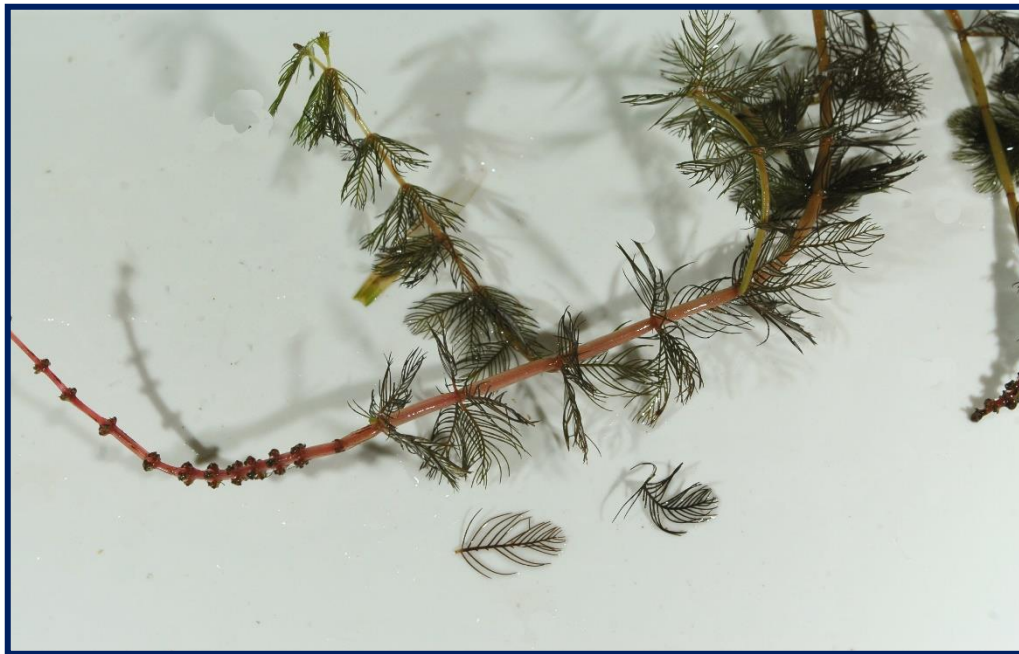
**Figure 10. Eurasian Watermilfoil (Seed head, lateral branch and main stem).**

The amount of Eurasian Watermilfoil (Figure 10) present in Big Star Lake varies each year and is dependent upon climatic conditions, especially runoff-associated nutrients. The May 25<sup>th</sup>, 2023 survey revealed that approximately 7.5 acres of milfoil were found throughout the entire lake. An additional 2.5 acres were found and all were treated on June 8<sup>th</sup> 2023 with the combination of ProcellaCOR® (6 PDU dose) and diquat (1 gal/acre dose). During the second whole-lake inventory survey on August 7<sup>th</sup>, 2023, there was an additional 10.4 acres of Eurasian Watermilfoil identified along with a few stands of emergent invasive Phragmites and Purple Loosestrife. These infestations were treated on August 14<sup>th</sup>, 2023 along with an additional 1.6 acres of Eurasian Watermilfoil. EWM growth in the lake will need to be re-evaluated in spring of 2024 and treated if it survives the winter. The 2023 treatment maps for the EWM are shown in the maps below (Figures 11 & 12)
